Nevada
Environmental
Restoration
Project

DOE/NV--1133

Post-Closure Inspection Report for
the Tonopah Test Range, Nevada

For Calendar Year 2005

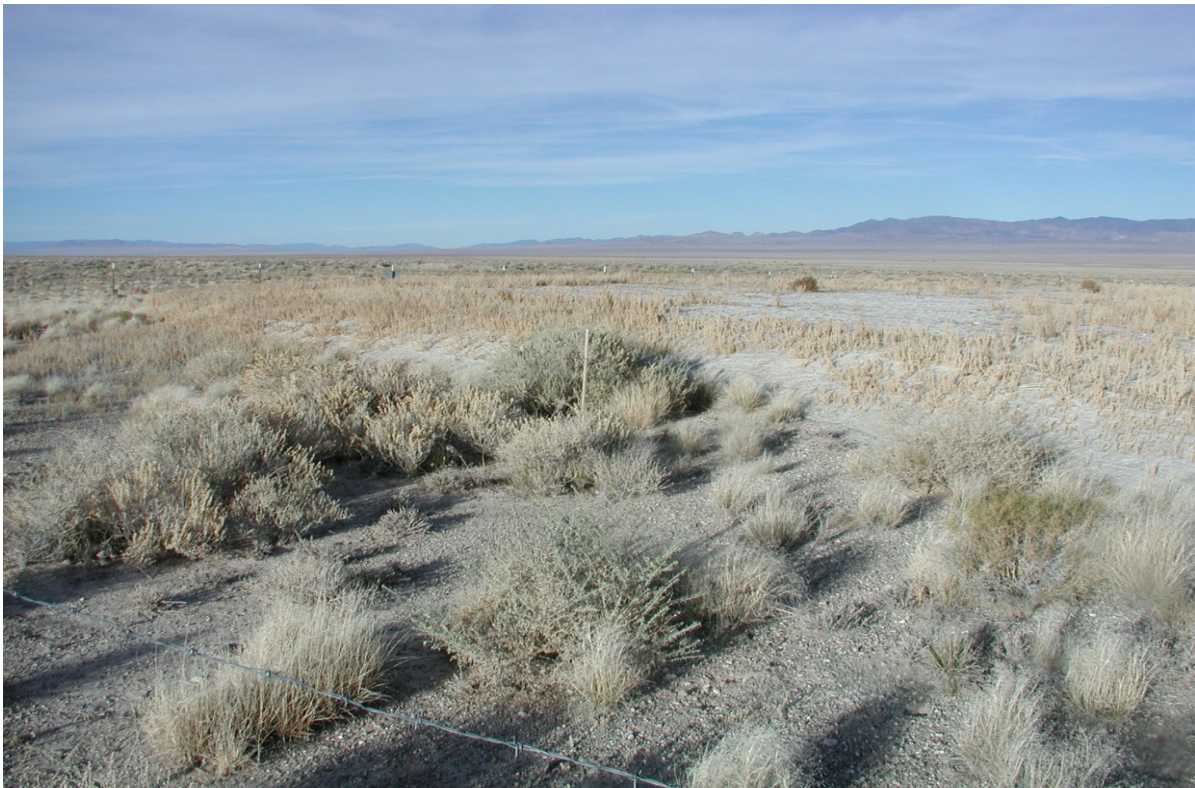
Photograph 14: CAU 407, looking northeast, 11/15/05

The second inspection was conducted on November 15, 2005. Small animal burrows were present within the fence, but do not affect the integrity of the cover. No erosion cracks or subsidence of the cover was observed during the inspection. The top strand of the barbed-wire fence was broken on the south side of the site, extending approximately 100 ft from the gate. Also, a radiological warning sign was loose due to high winds. The wire strand and warning sign were temporarily reattached during the inspection.

During the November 2005 inspection of CAU 407, a loose strand of barbed wire and a radiological warning sign were temporarily reattached. Re-tensioning the barbed wire fence and permanently reattaching the warning sign is scheduled for the first quarter of 2006. Also, the cover was reseeded in December 2004 and was irrigated in February, March, and April, 2005, to supplement natural precipitation to encourage seed germination.

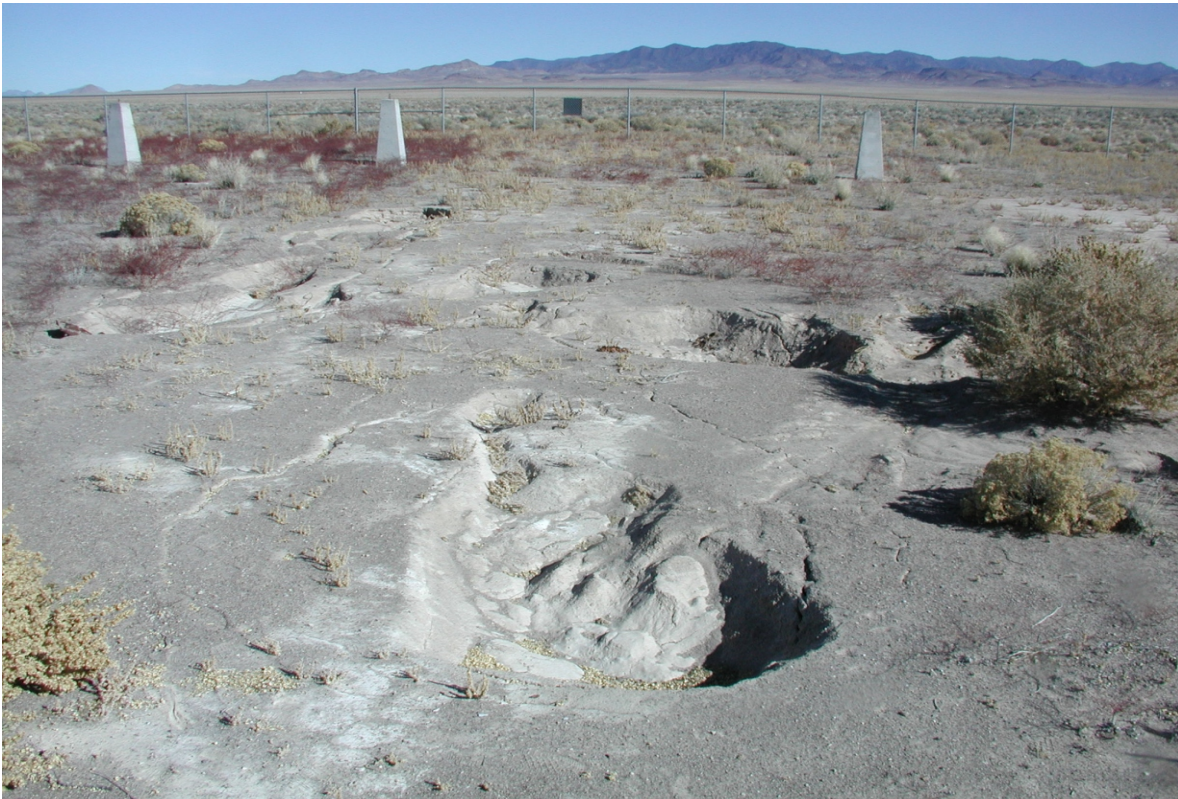
Photograph 41: CAU 453, soil subsidence, 11/16/05

During the November 2005 site inspections several issues that require maintenance and repairs were noted. These included: subsidence of landfill cell covers at CAU 453; loose and downed fencing and warning signs at CAU 407; downed monuments at CAU 487. Repairs and maintenance are scheduled for the first quarter of 2006, within 90 working days of discovery.

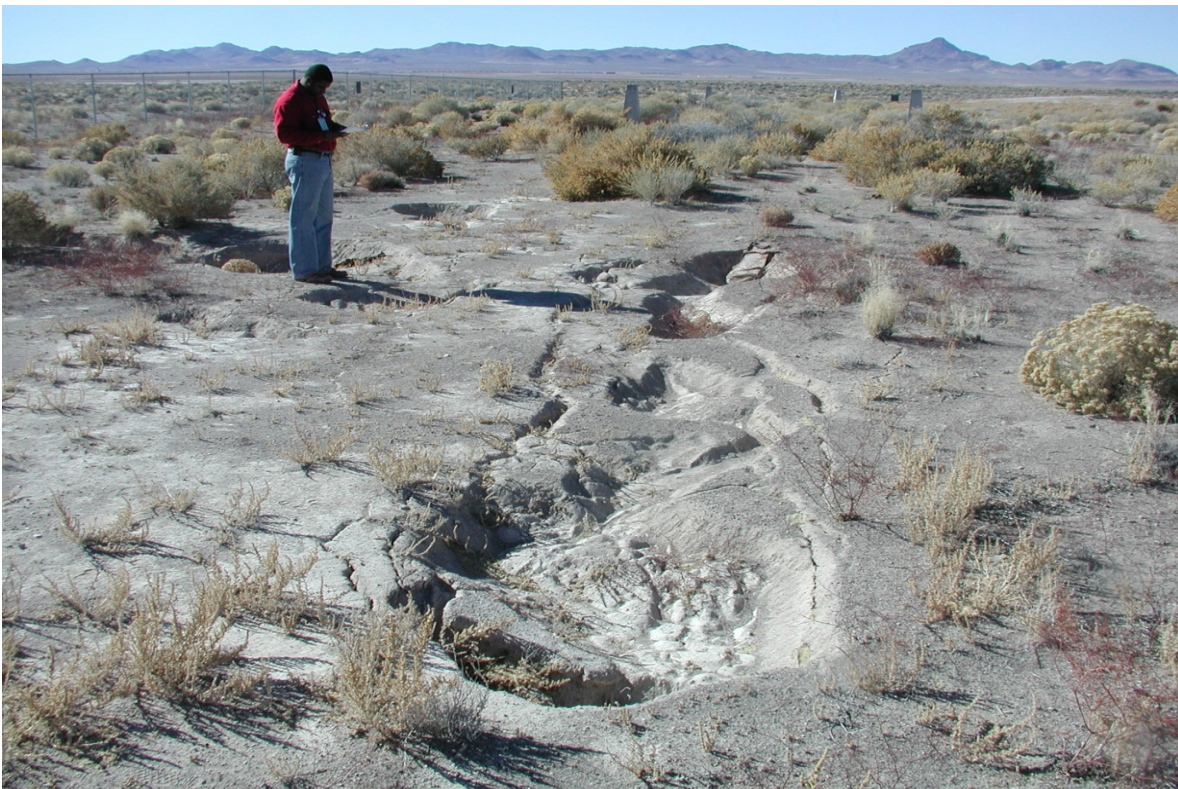
Photograph 42: CAU 453, soil subsidence, 11/16/05

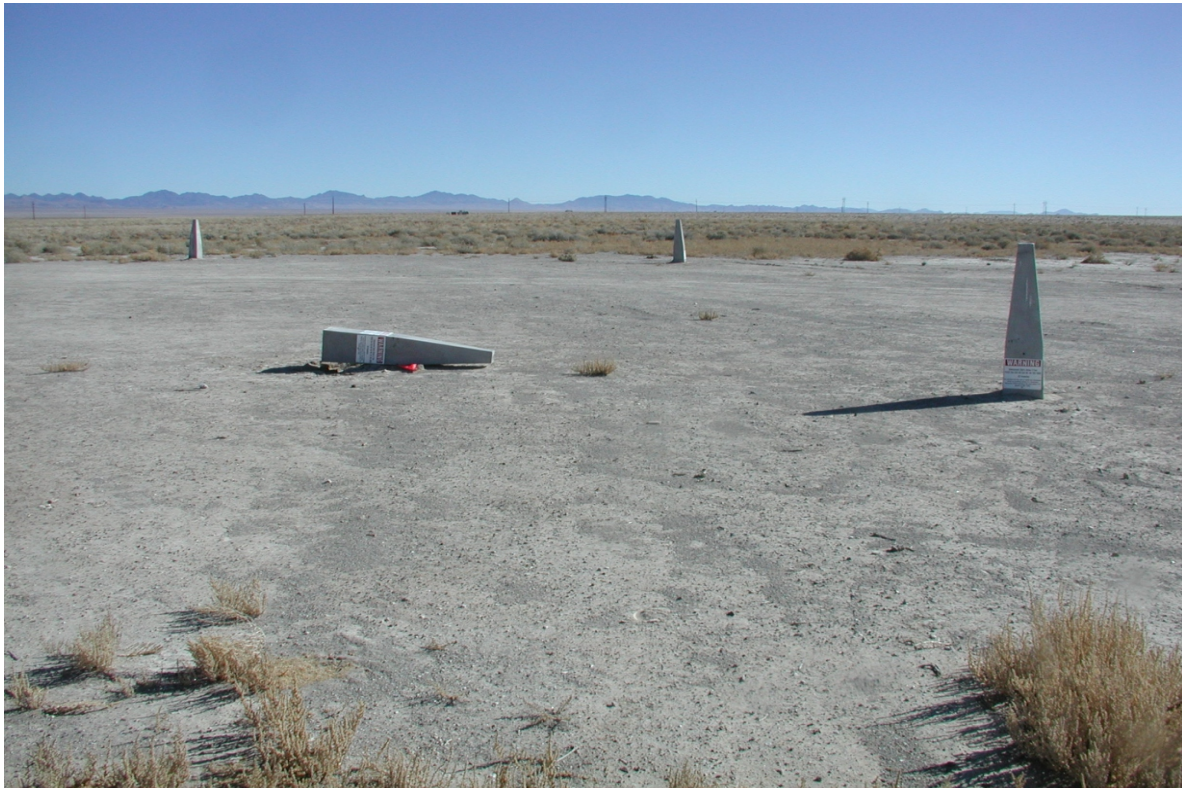
Photograph 45: CAU 487, A-8 anomaly, fallen monument, 11/16/05

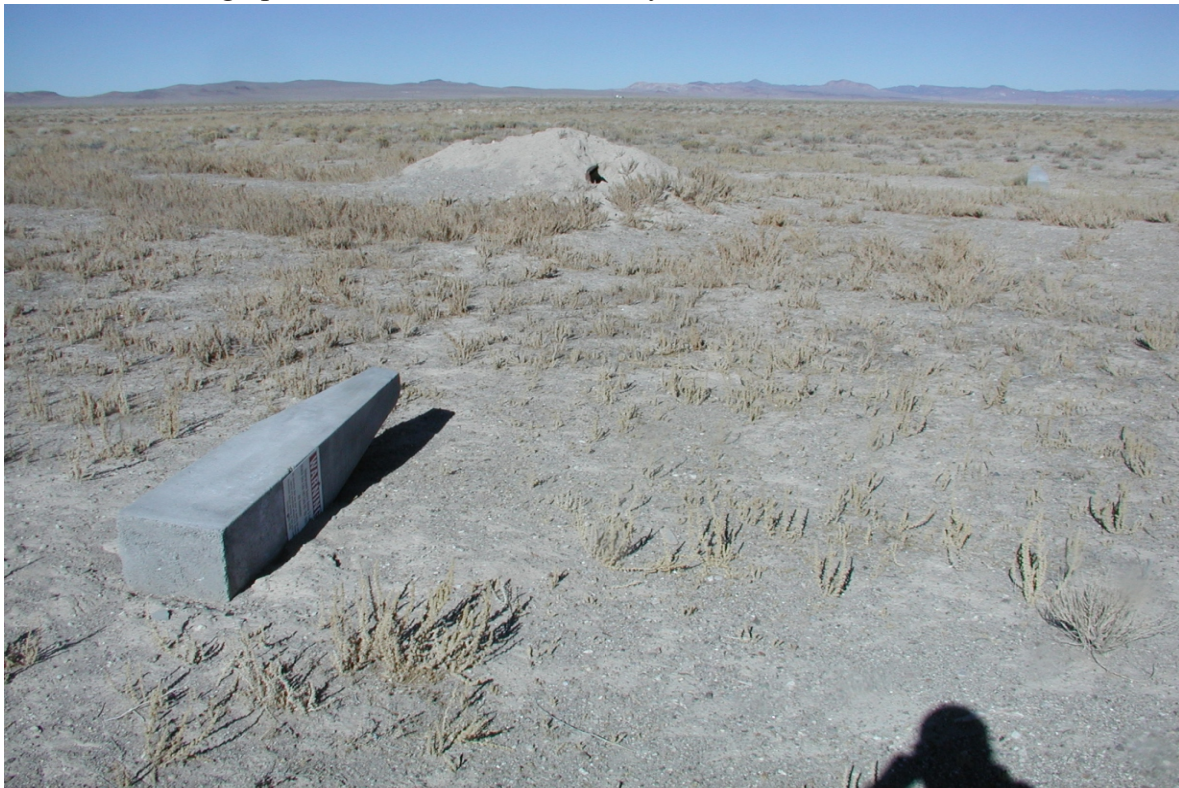
Photograph 46: CAU 487, A-17 anomaly, fallen monuments, 11/16/05

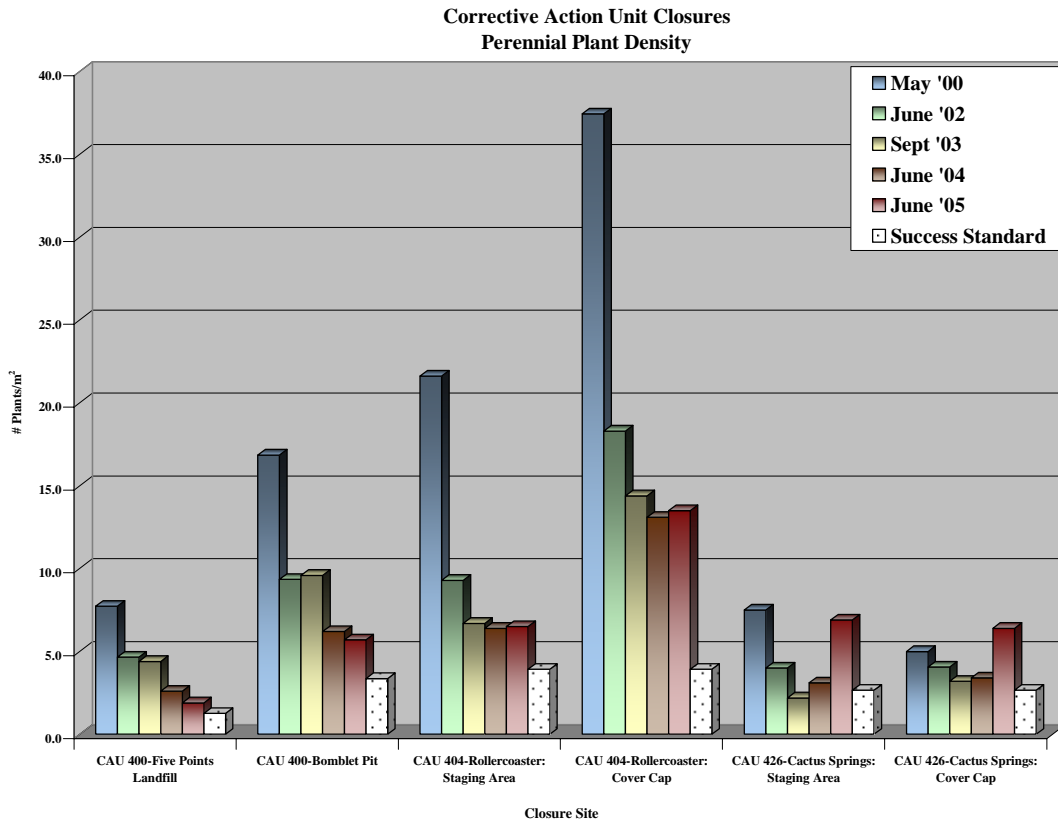
CAU 400: Five Points Landfill - Plant density at this site is the lowest plant density of any of the CAUs that were revegetated in 1997 (Figure 4). Although there are less than 2 plants/m² it exceeds the goal of 1.3 plants/m². The plants that are establishing on the site are fourwing saltbush, winterfat, squirreltail grass and Indian ricegrass, all species native to the area. This year there was an abundance of native perennial species. To date there have not been any problems with invasive weedy species at this site. The newly reseeded portion of the site should be monitored to insure such species do not impede the establishment of native perennial species.

Figure 4. Plant density on all CAU s over the last five years and compared to plant densities on adjacent native plant communities.

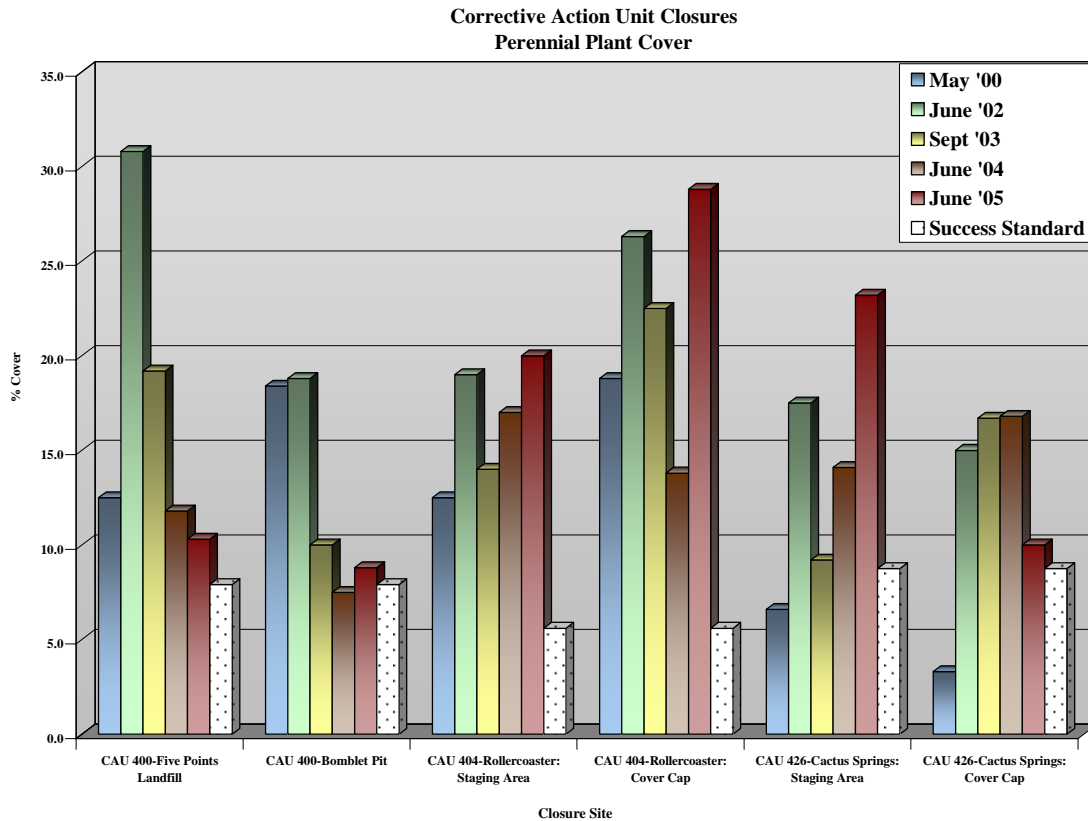
Plant cover at this site was about 10%, which is the lowest that it has been since the site was reseeded (Figure 5). The low cover is in part due to the dry conditions that have existed at the site for the 2-3 years prior to this year and also to the flash flood that impacted a significant portion of the vegetation last fall. Although plants may not have recovered fully from the drought and flash flood, perennial plant cover still exceeds the plant cover goal of 8% (70% of the 11% measured this year). The drier conditions experienced in this region the previous 3 years appear to have affected grasses more than shrubs. The contribution of grasses to overall perennial plant cover has declined over the last few years from a high of 80% of the cover in 2000 to only 13% this year.

Figure 5. Plant cover for all CAUs over the last five years and compared to plant cover on adjacent native plant communities.
